Determination of the contribution to the fire resistance of structural steel members by an applied profiled reactive water-based fire protective system type ENVIROGRAF® EP/FS/IN/EX, according to EN 13381-8:2013
Test report

Report no.	2019-Efectis-R000566
Sponsor	Intumescent Systems Ltd Envirograf House Barfrestone CT15 7JG DOVER UNITED KINGDOM
Author(s)	P.W.M. Kortekaas Ir. T. Rakovec M. van der Meulen B.Sc.
Project number	ENL-18-000645
Date of issue	April 2019
Number of pages	67

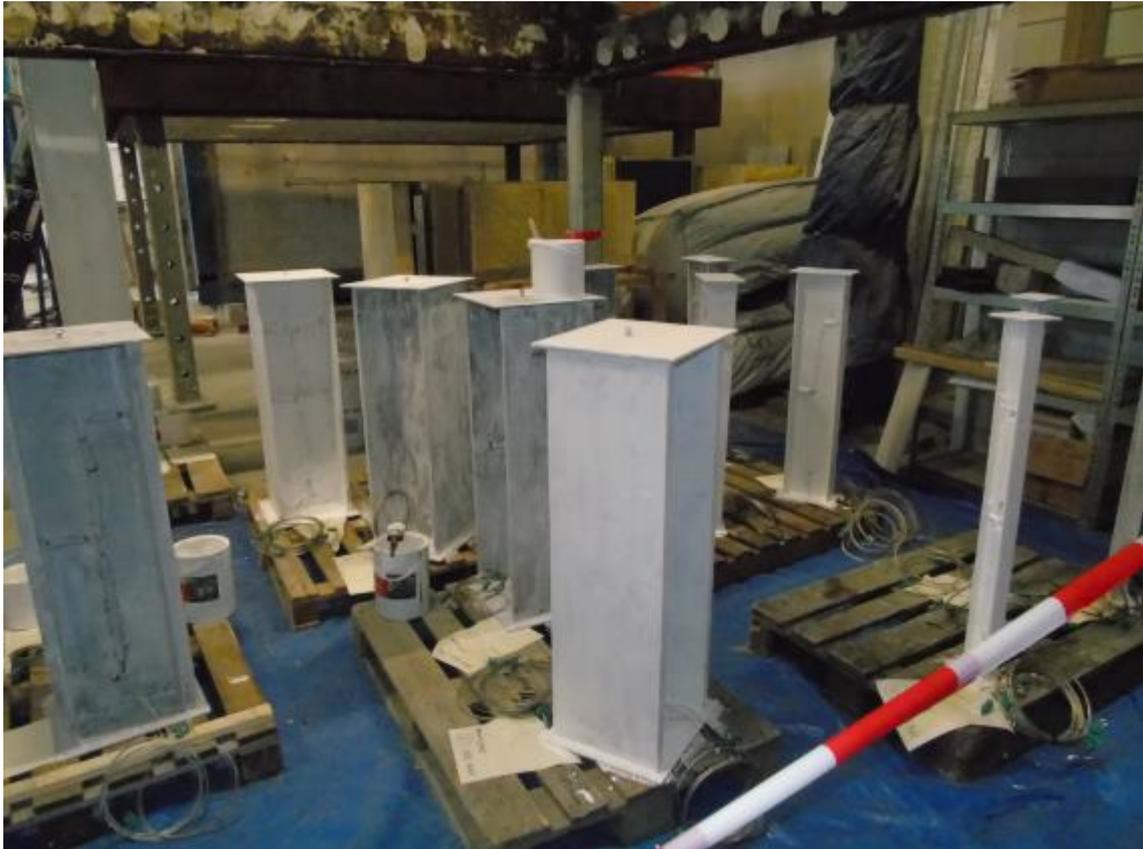
Photo D.3 Application of the coating on the short columns

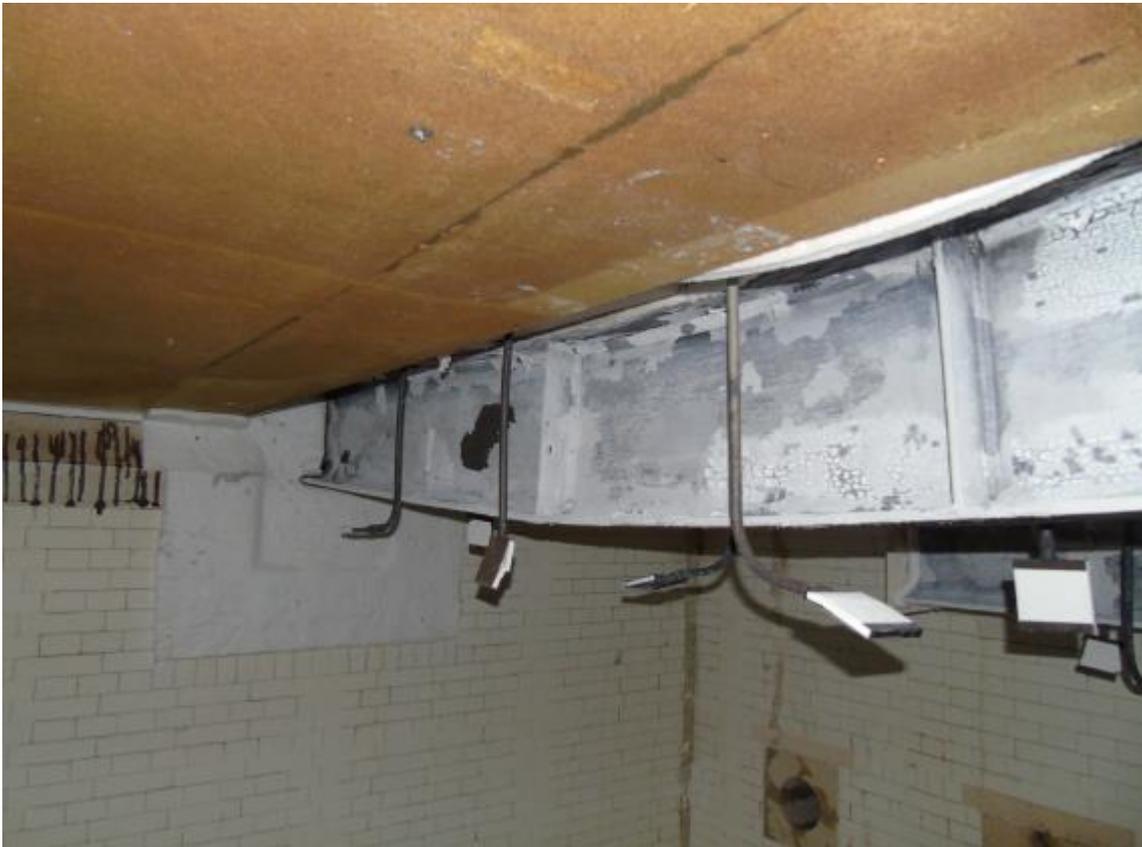
Photo D.6 Test 1: Loaded beam with minimum protection thickness after the test

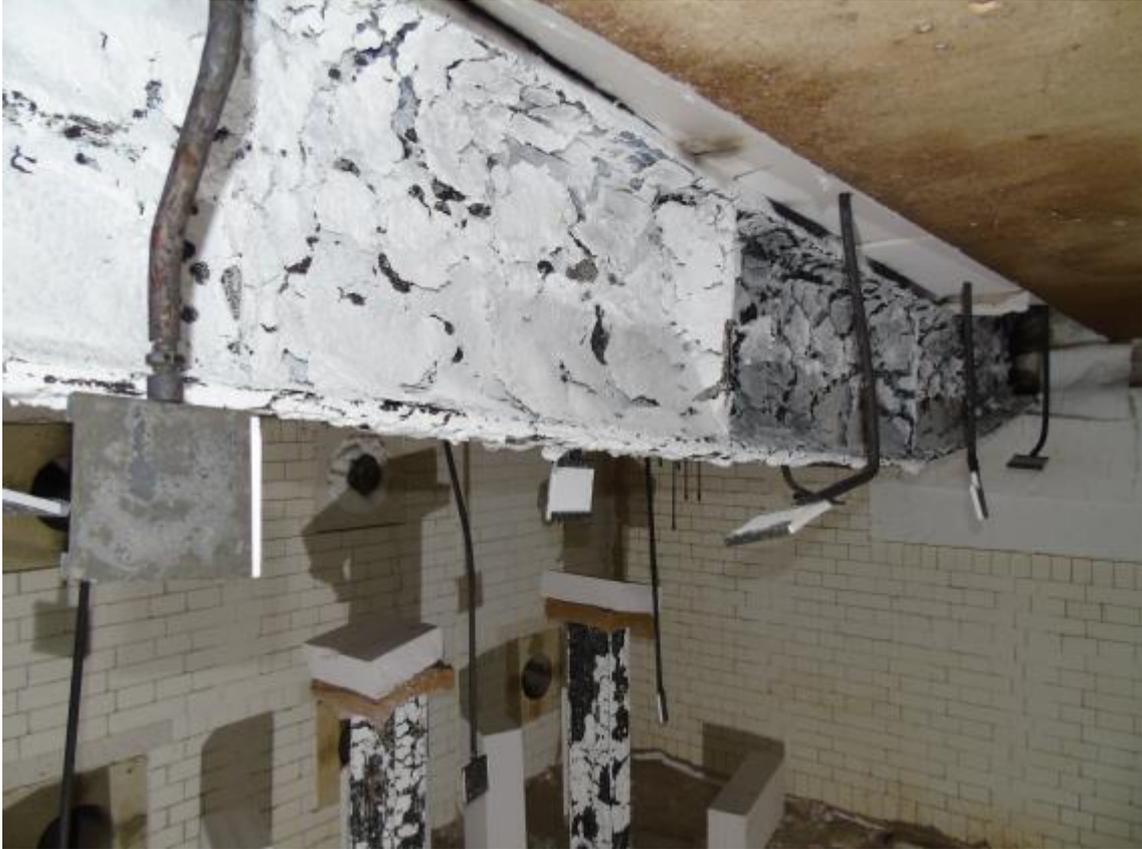
Photo D.11 Test 2: Loaded beam with maximum protection thickness after the test (1)

Time (min)	Observation
0	Start of heating
15	It seems that material is falling of the lower flange of the loaded beam.
37	The rate of deflection exceeded
38.5	Max. deformation of the loaded beam reached
40	The applied load was removed
67	End of heating

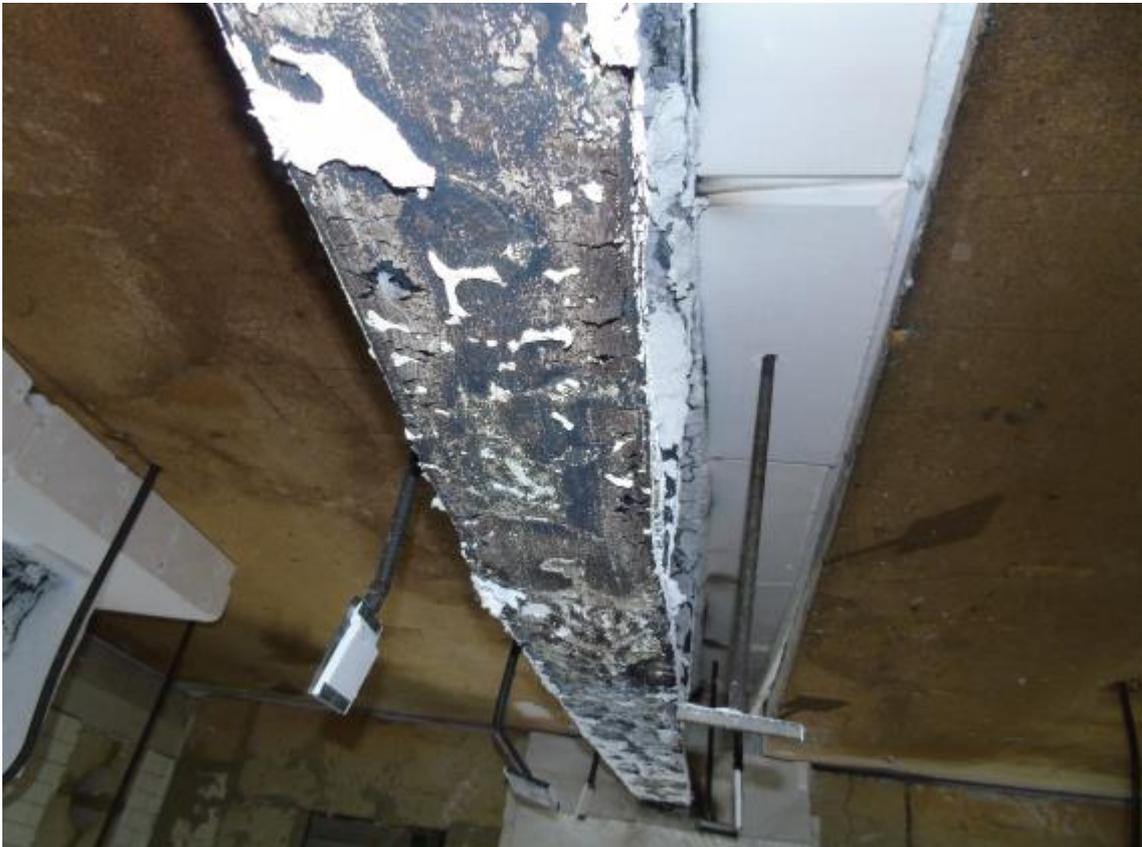
Photo D.12 Test 2: Loaded beam with maximum protection thickness after the test (2)
